**DEPARTMENT OF TRANSPORTATION**

Contract #: 04-0120F4Cty: SF/ALA Rte: 80 PM: 13.2/13.9File #: 69.28**WELDING INSPECTION REPORT****Resident Engineer:**Siegenthaler, Peter**Address:** 333 Burma Road**City:** Oakland, CA 94607**Report No:** WIR-022149**Date Inspected:** 26-Mar-2011**Project Name:** SAS Superstructure**OSM Arrival Time:** 1500**Prime Contractor:** American Bridge/Fluor Enterprises, a JV**OSM Departure Time:** 300**Contractor:** Zhenhua Port Machinery Company, Ltd (ZPMC), Changxing Island **Location:** Shanghai, China**CWI Name:** Mr. Liu Hua Jie ZPMC**CWI Present:** Yes No**Inspected CWI report:** Yes No N/A**Rod Oven in Use:** Yes No N/A**Electrode to specification:** Yes No N/A**Weld Procedures Followed:** Yes No N/A**Qualified Welders:** Yes No N/A**Verified Joint Fit-up:** Yes No N/A**Approved Drawings:** Yes No N/A**Approved WPS:** Yes No N/A**Delayed / Cancelled:** Yes No N/A**Bridge No:** 34-0006**Component:** BAY14 OBG**Summary of Items Observed:**

## WELDING INSPECTION REPORT

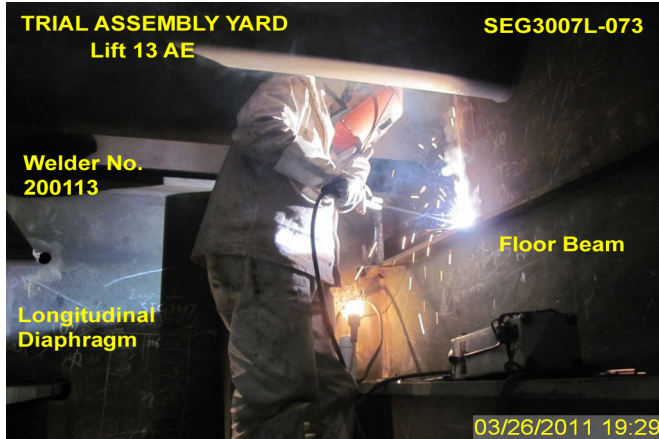
FCAW welding of complete joint penetration weld joint(s) located on lift 13AE, SEG3007AH Floor Beam I-Rib to Grillage weld number(s) 036, 038, 094. Welder is identified as welder no. 050242. The welding variables recorded by ZPMC QC identified as Zhan Hai Feng appeared to comply with applicable WPS(s) WPS-B-2-2231 ESAB.
